“Blucher Bunch” Erosion Control Efforts in a City Park

- Chapter: South Texas
- Presenters: Jon Brandt & Bibi Dalrymple

Working with City staff to mitigate several erosion problems at Blucher Park, in Corpus Christi

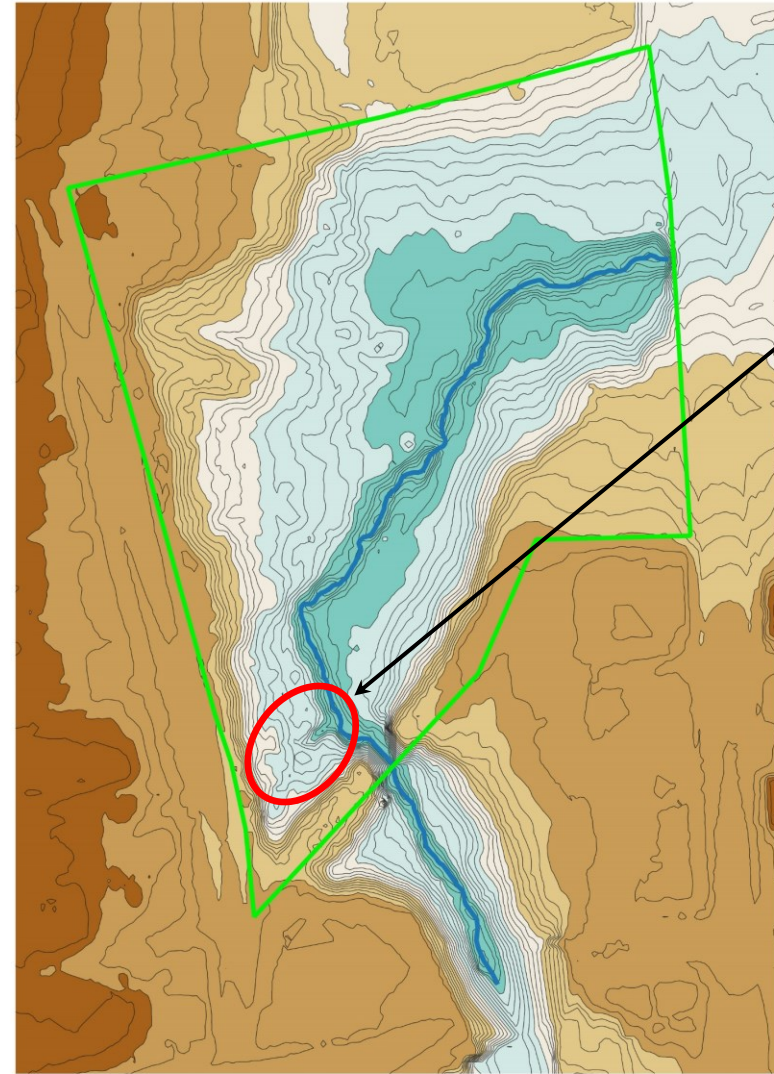
Blucher Park Topography

Based on USGS DEM data from 2018

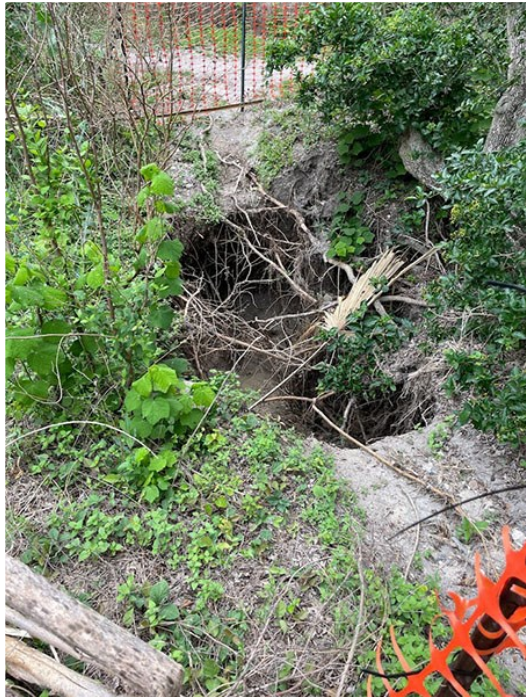
Expanding Large Gully

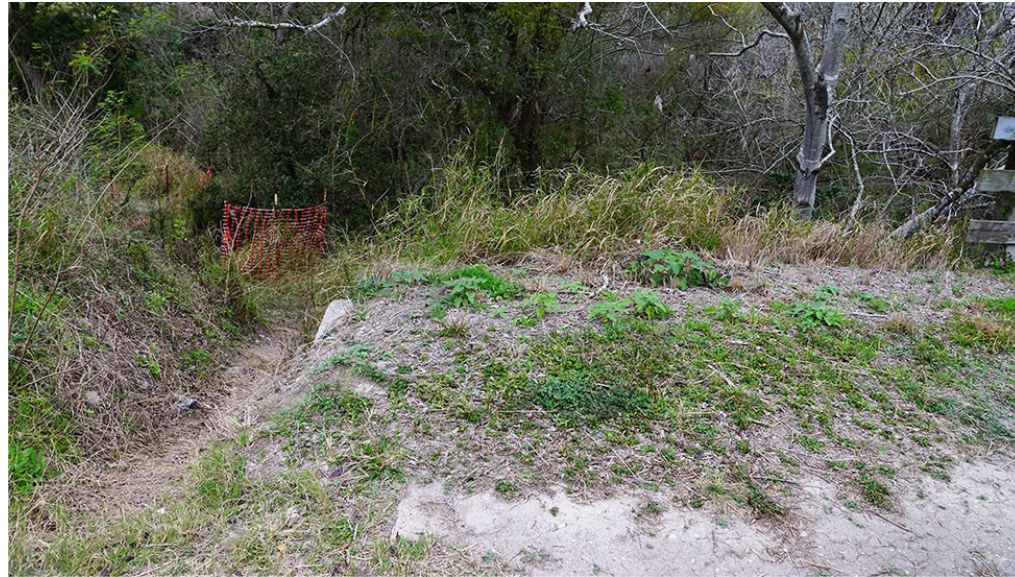
Trestle Gully

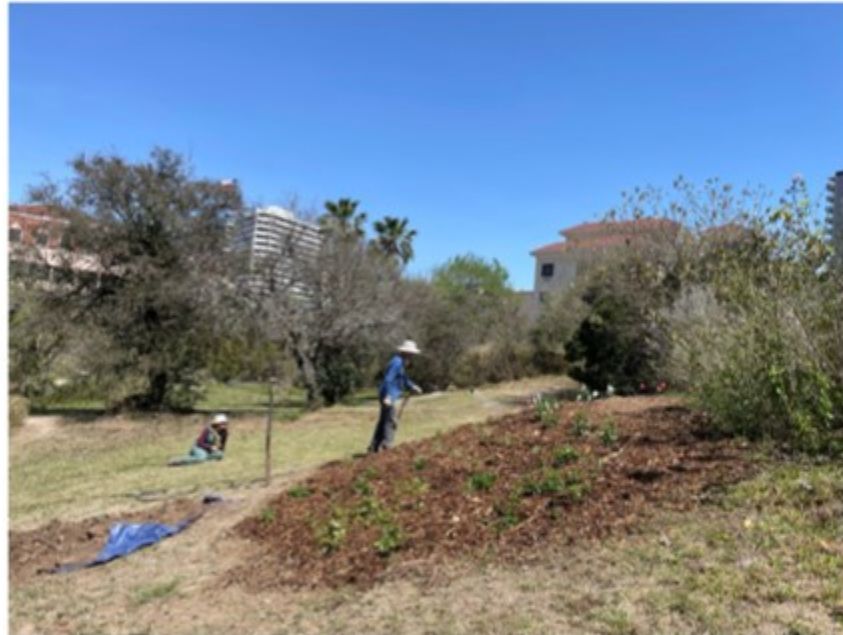
March 2022

Unvegetated slope showed signs of erosion. Added over 100 native plants including shrubs, grasses, and forbs.

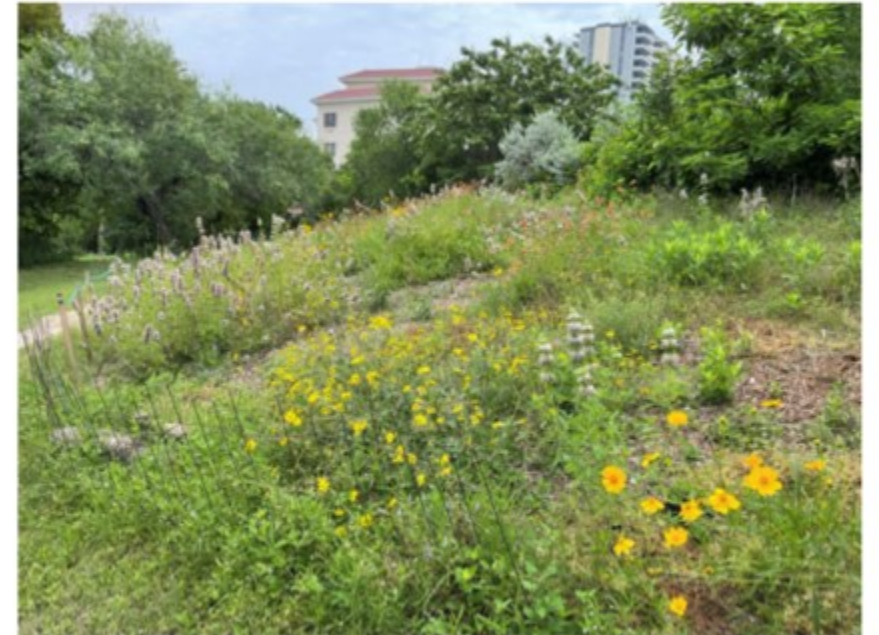
March 2023

Watered regularly summer of 2022; added wildflower seeds in fall of 2022.

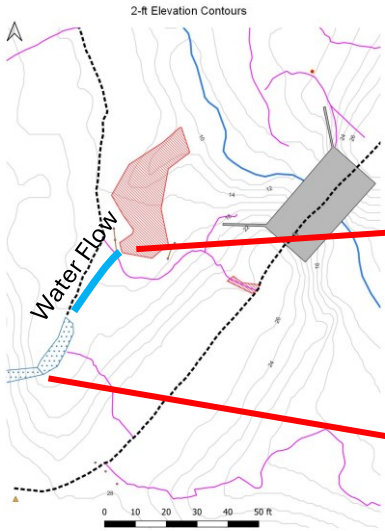
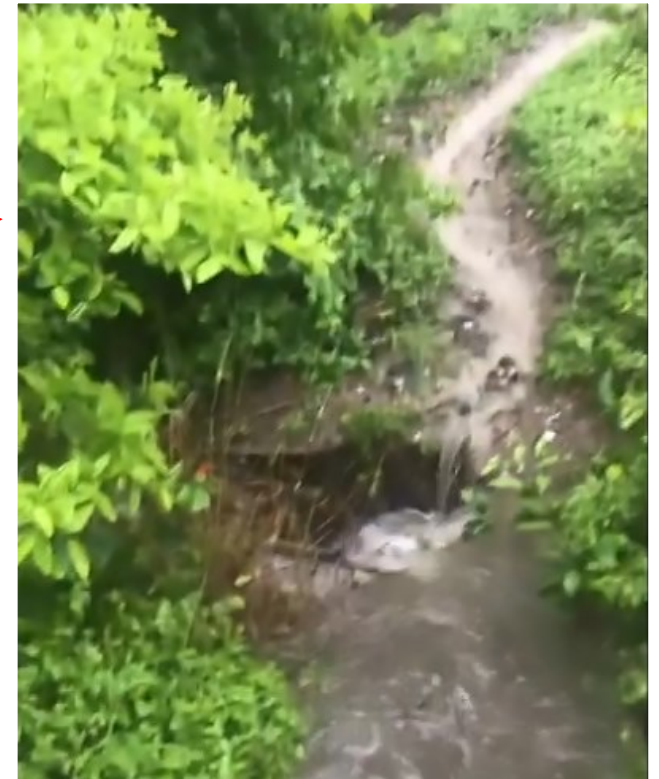
June 2020

Gully was expanding upslope. Appeared erosion has been accelerating.

- (1) Trail loss
- (2) Fall hazard
- (3) Degraded water quality
- (4) Can eventually jeopardize stormwater outlet

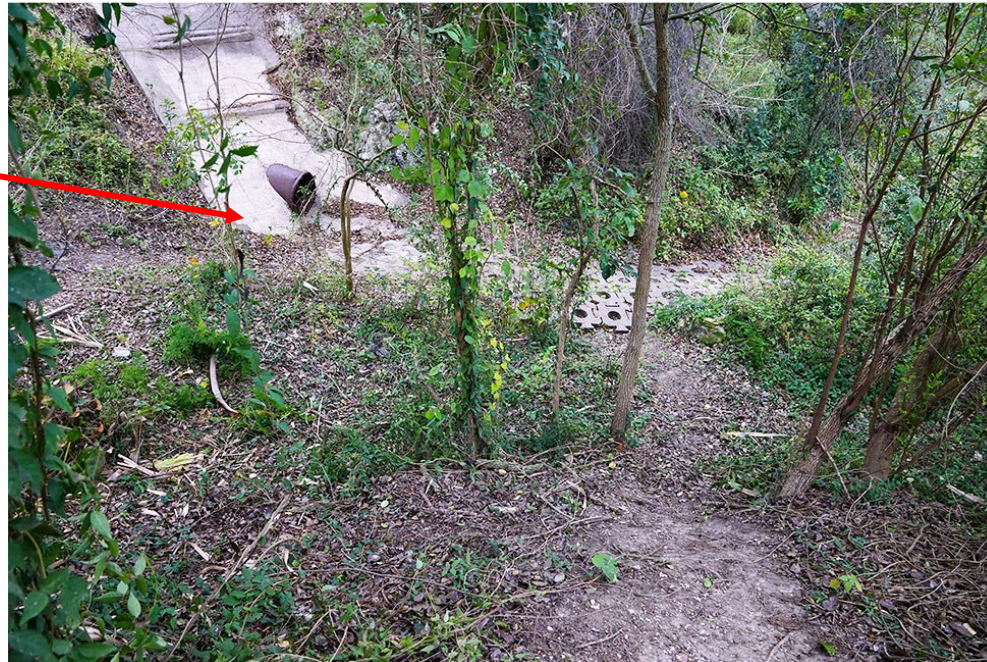
Majority of water coming from stormwater outlet. Water runs above ground and down a trail, until it reaches Blucher Creek.

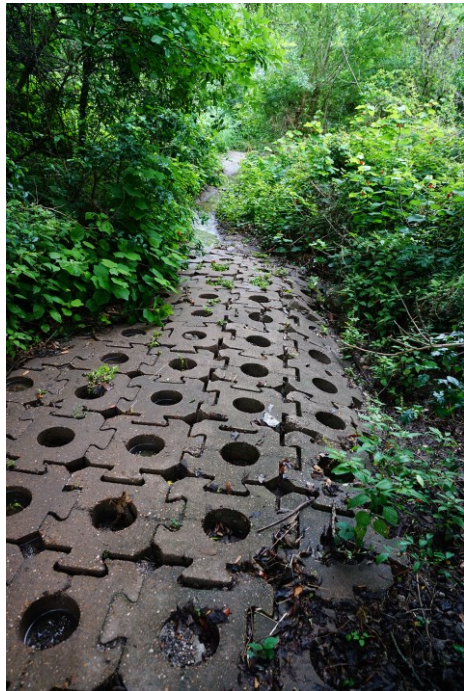
Articulated Concrete Blocks collapsing on right side, being undercut

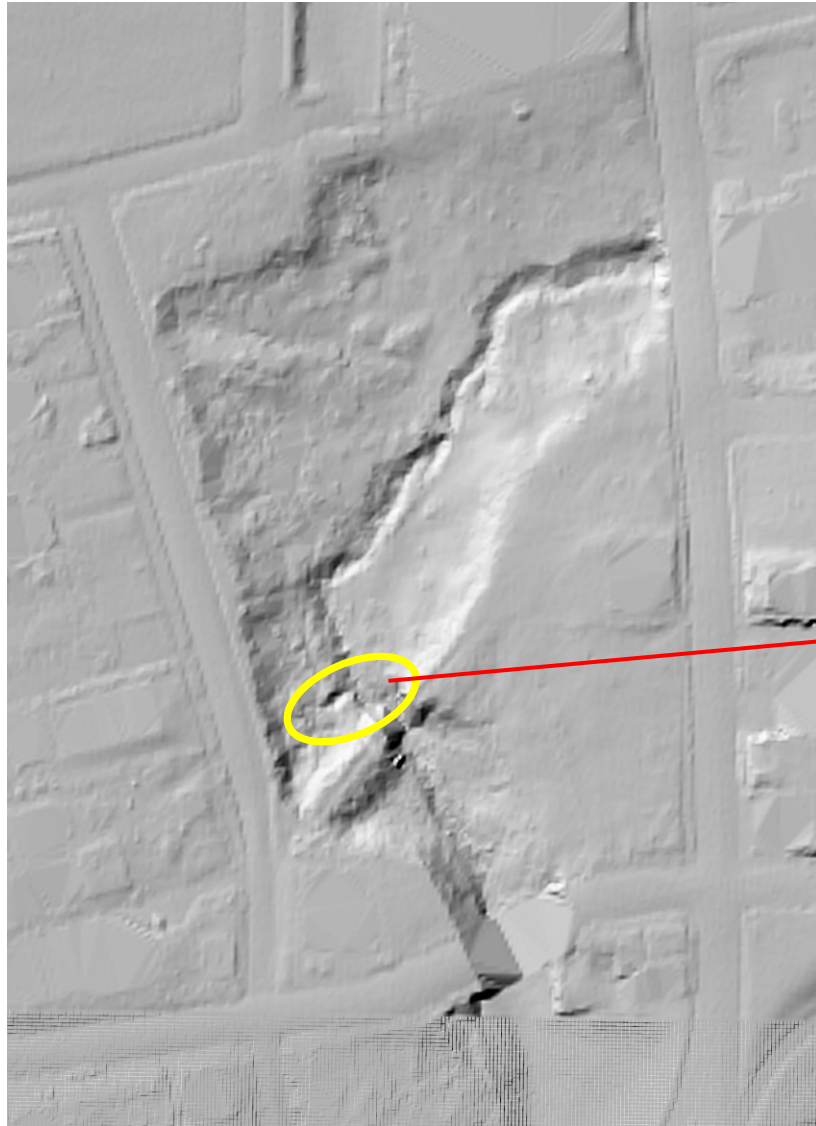
Hillshade rendering, showing landscape features, 2018 Lidar Data collected by USGS

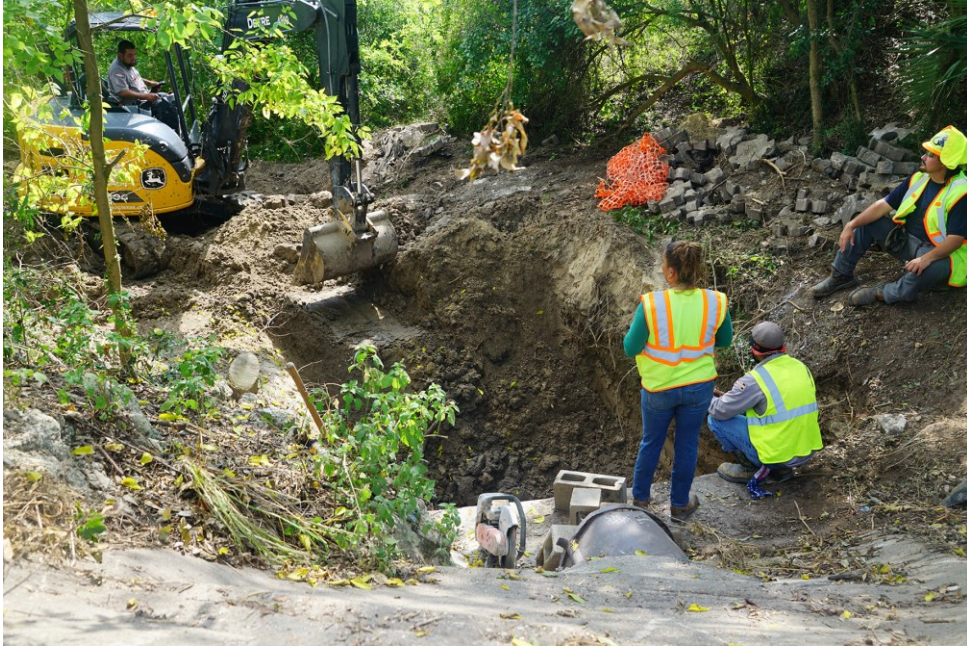
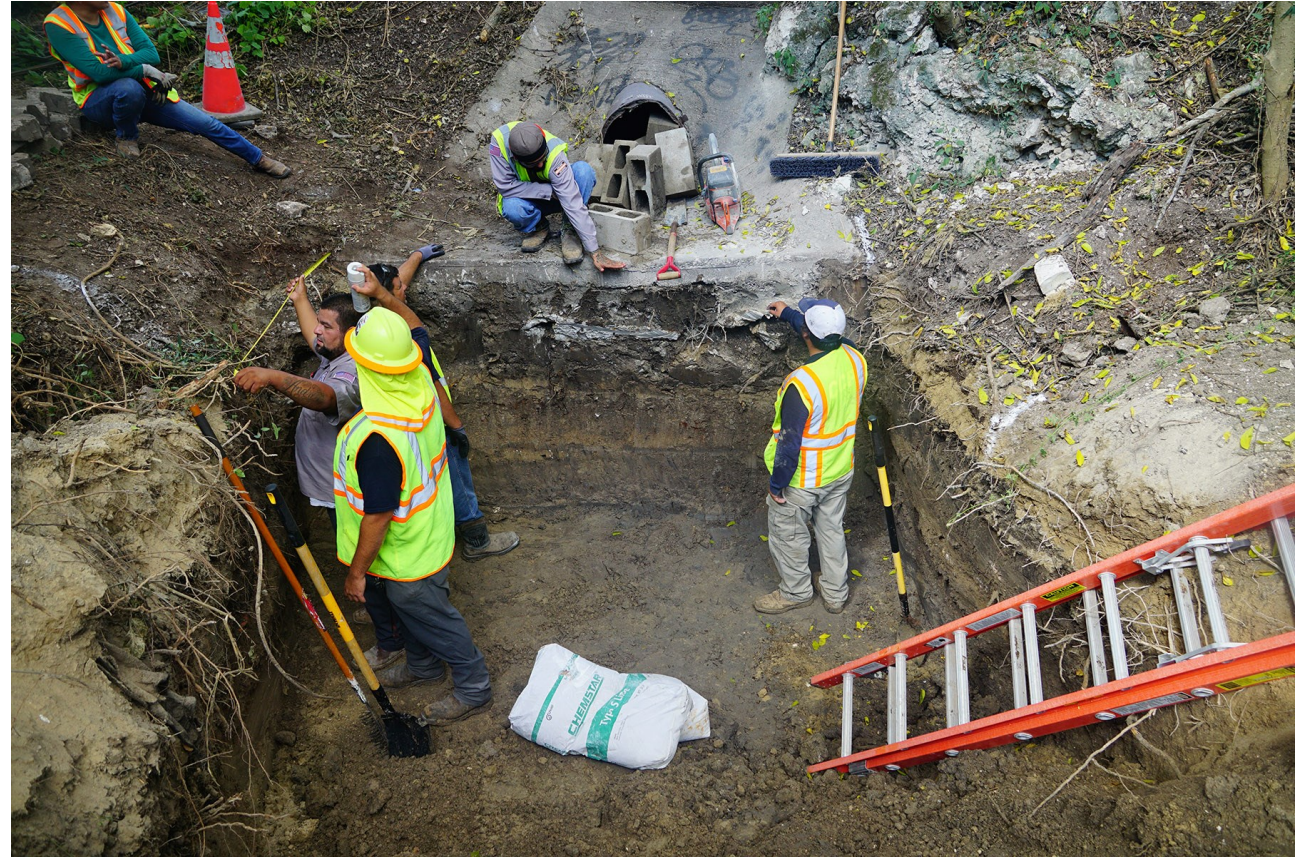
June 11, 2024

Buried 18-inch diameter
corrugated steel pipe,
draining catchment box,
leading to Blucher Creek

Corpus Christi Stormwater Department Construction

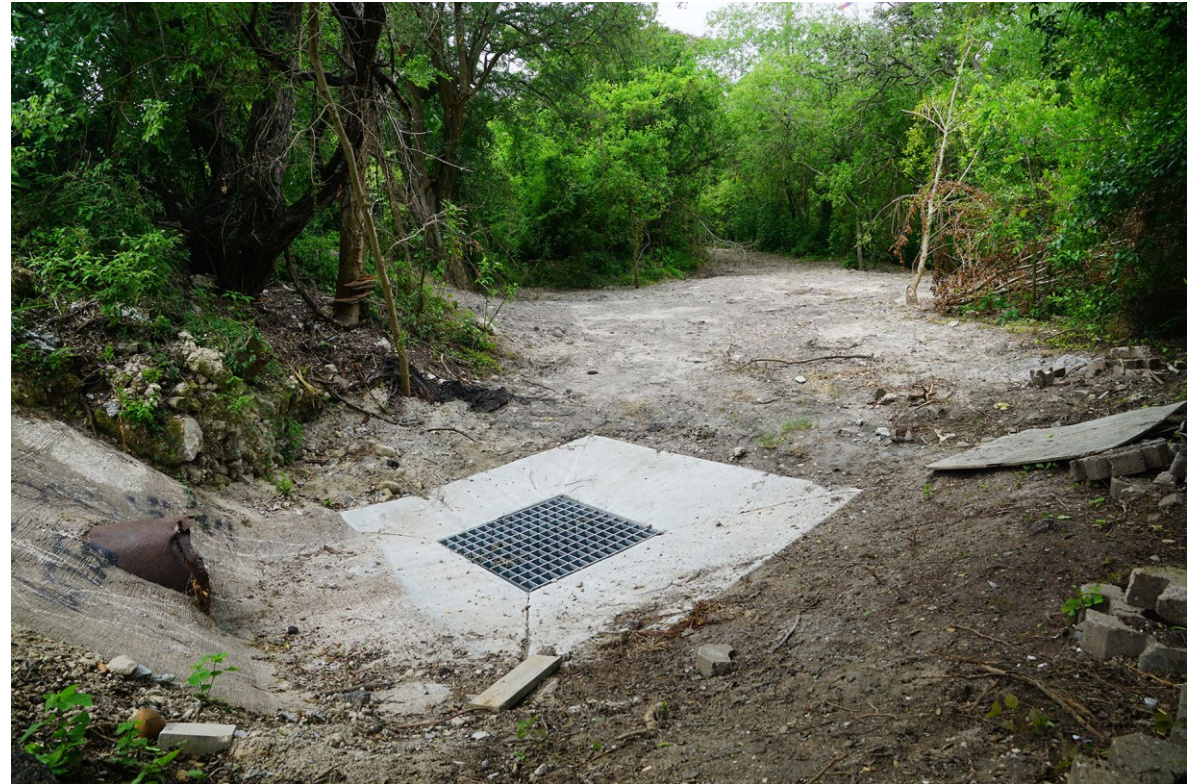
July 15, 2024

Much of the gully erosion has been mitigated; however, there is the remaining issue of handling large rainfall events (TS Alberto and late July).

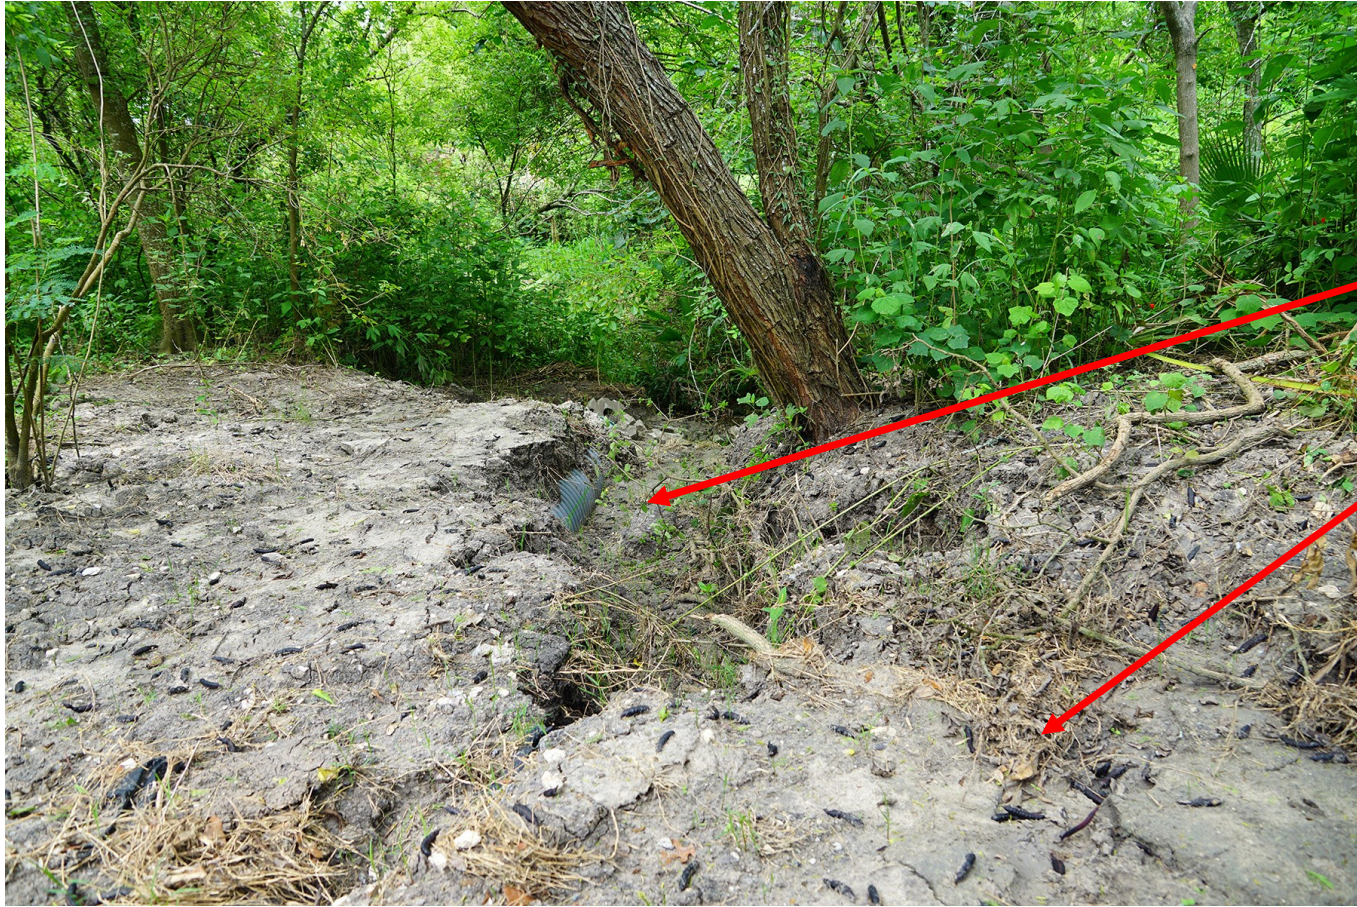
Fill material easily eroded, exposed pipe

Concentrated water flow

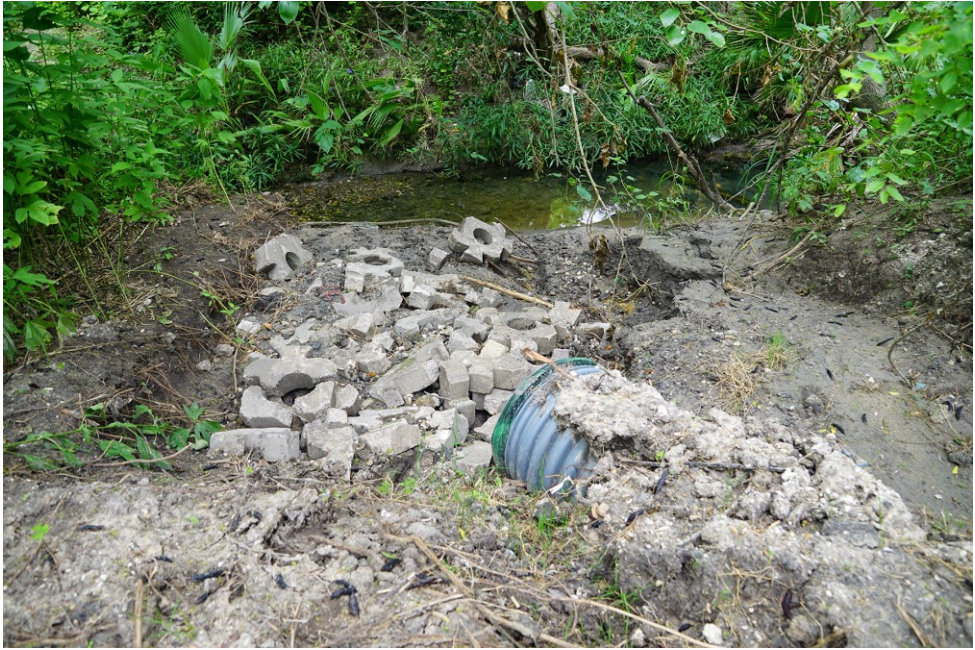
July 15, 2024

Overland flow, from water bypassing the grate,
caused erosion

- planting/mulching bare ground
- Installing barrier so above normal water flows do not bypass the grate and pipe
